Manhole Inspection Summary

Manhole # S31SS_029MH

Location Address: **2810 FOX ST**

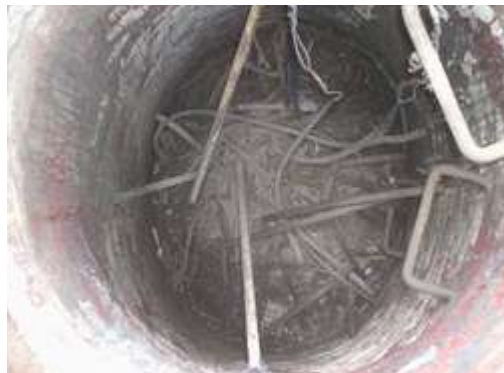
Top View

Channel debris.

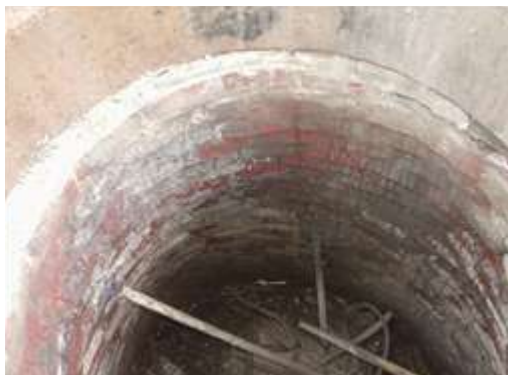
Defect

Frame leaks. Adjustment deterioration and infiltration Corbel and Barrel infiltration - other side.

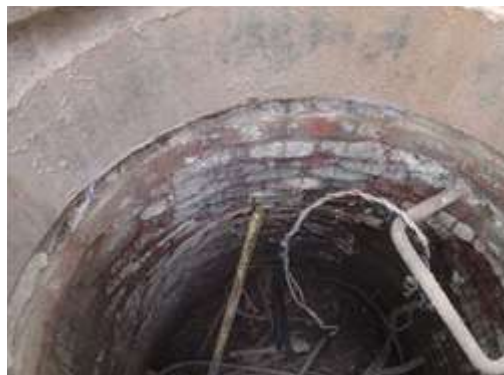
Defect

Frame leaks. Adjustment deterioration and infiltration Corbel and Barrel infiltration.

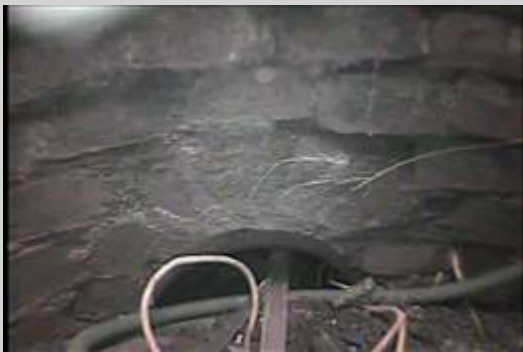
8 in. Circular Gravity Sewer
Pipe Out @ 12 O'Clock

Barrel root intrusion.
